Mercedes 722.1-722.2

Mercedes automatic transmission technical tips

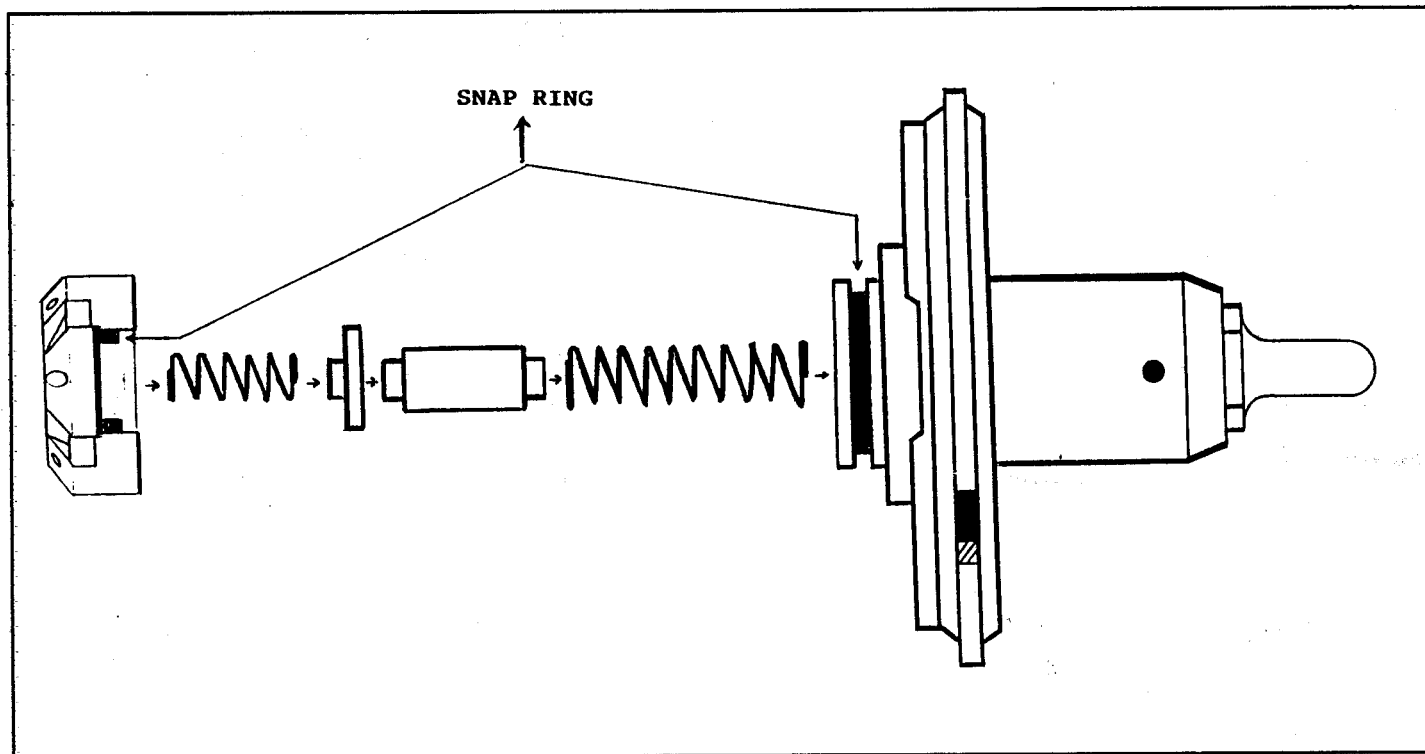
COMPLAINT: No Forward / slipping in Drive
Coast downshift clunk or bump.
Delayed engagement in Drive.

CAUSE: Broken plastic cap on servo piston.
Improper installation of spring seat.
Improper installation of servo piston spring.

CORRECTION: Be sure to have exhaust valve line-up as shown in Figure 1.
Be sure to install spring line-up as shown and spring seat installed as shown in Figure 1
Be sure that plastic cap is seated on servo piston as shown in Figure 1 and the spring line up on piston as shown in Figure 2
spring is seated on TOP of servo piston NOT on bottom.

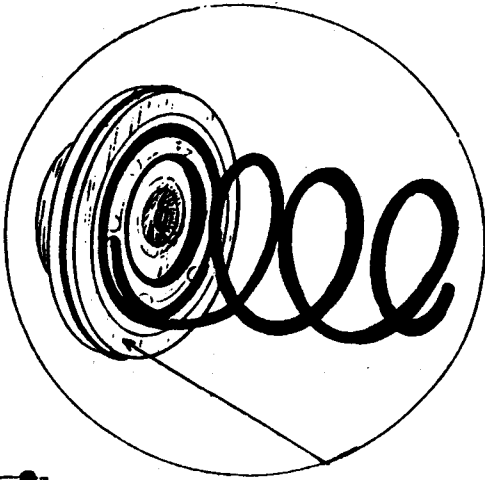
This illustration shows the correct installation of the servo spring. It must be placed on TOP of the servo piston and against the cover.

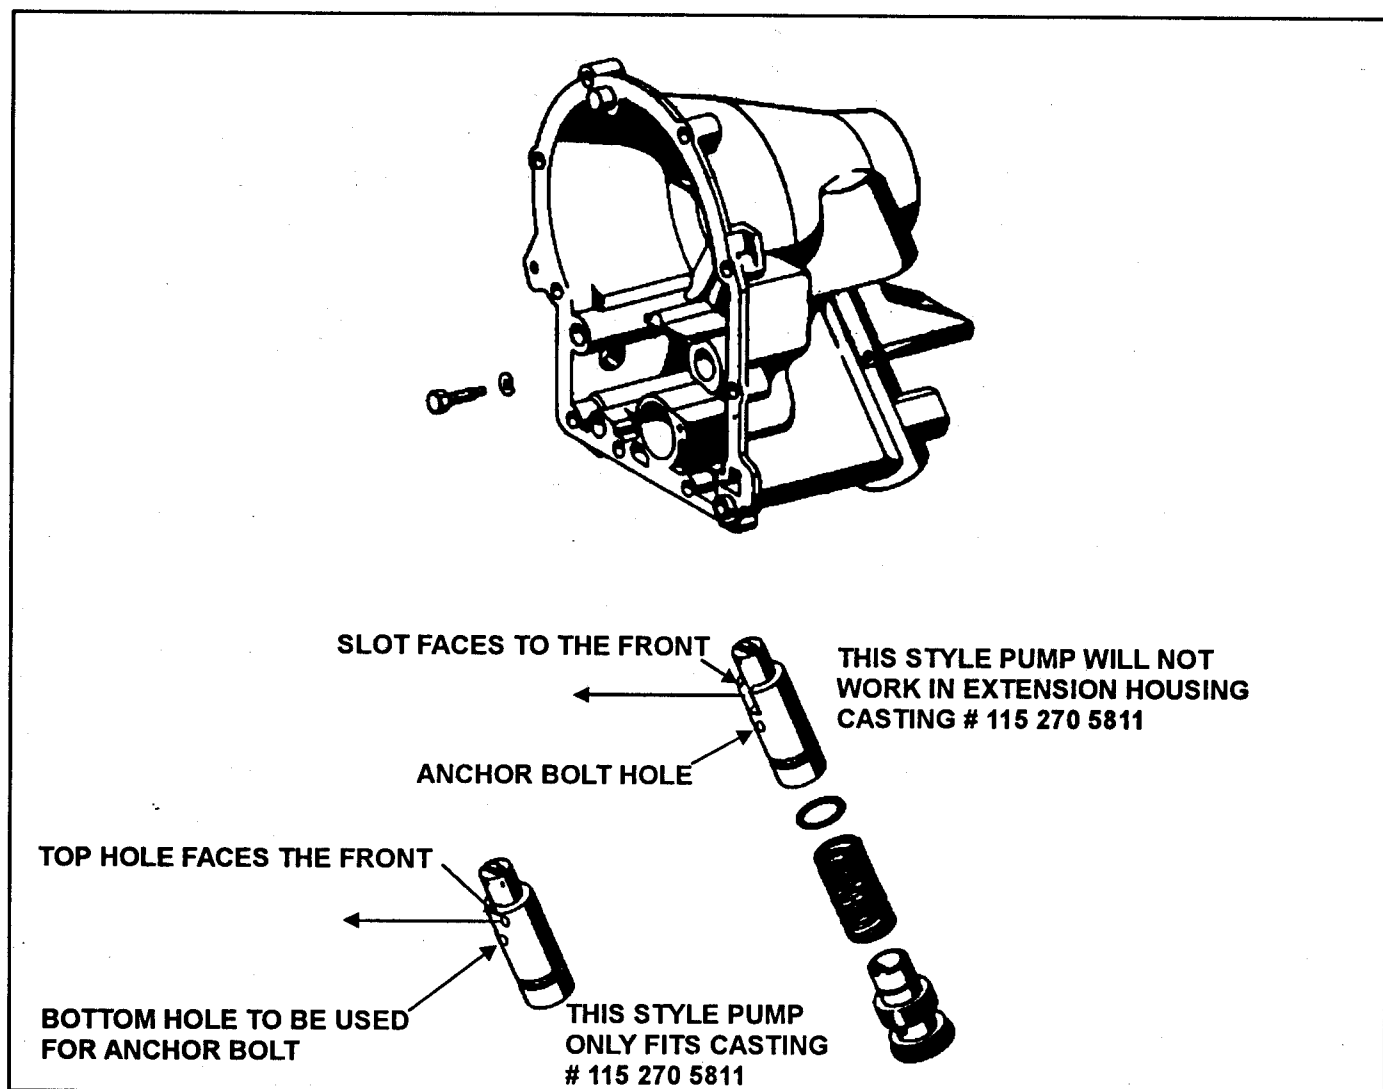
- COMPLAINT:** After overhaul, the transmission may experience chronic rear seal leaks or rear seal blow outs.
- CAUSE:** Incorrect assembly of the rear (secondary) pump in the extension housing allowing exhaust pressure from the pump to pressurize the back side of the seal.

- CORRECTION:** Install the secondary rear pump with the slot facing towards the front of the transmission and not towards the back (See Figure 1). There is also another style pump where there are two holes on one side of the shaft with a slot on the opposite side. This style should have the slot towards the back with the two holes towards the front of the transmission (See Figure 1). Be sure to use the bottom hole for the anchor bolt. If the top hole is used, the roller on the pump will be destroyed. This style secondary rear pump with two holes will only fit in an extension housing with casting number 115 270 5811. The design with the slot and hole will NOT fit properly in this extension housing as the anchor bolt hole will not line up with the hole in the casting.
