# Technical Service Information

## MERCEDES 722.3 / .4 HARSH REVERSE AFTER REBUILD CHECK VALVE IN PUMP IS OK

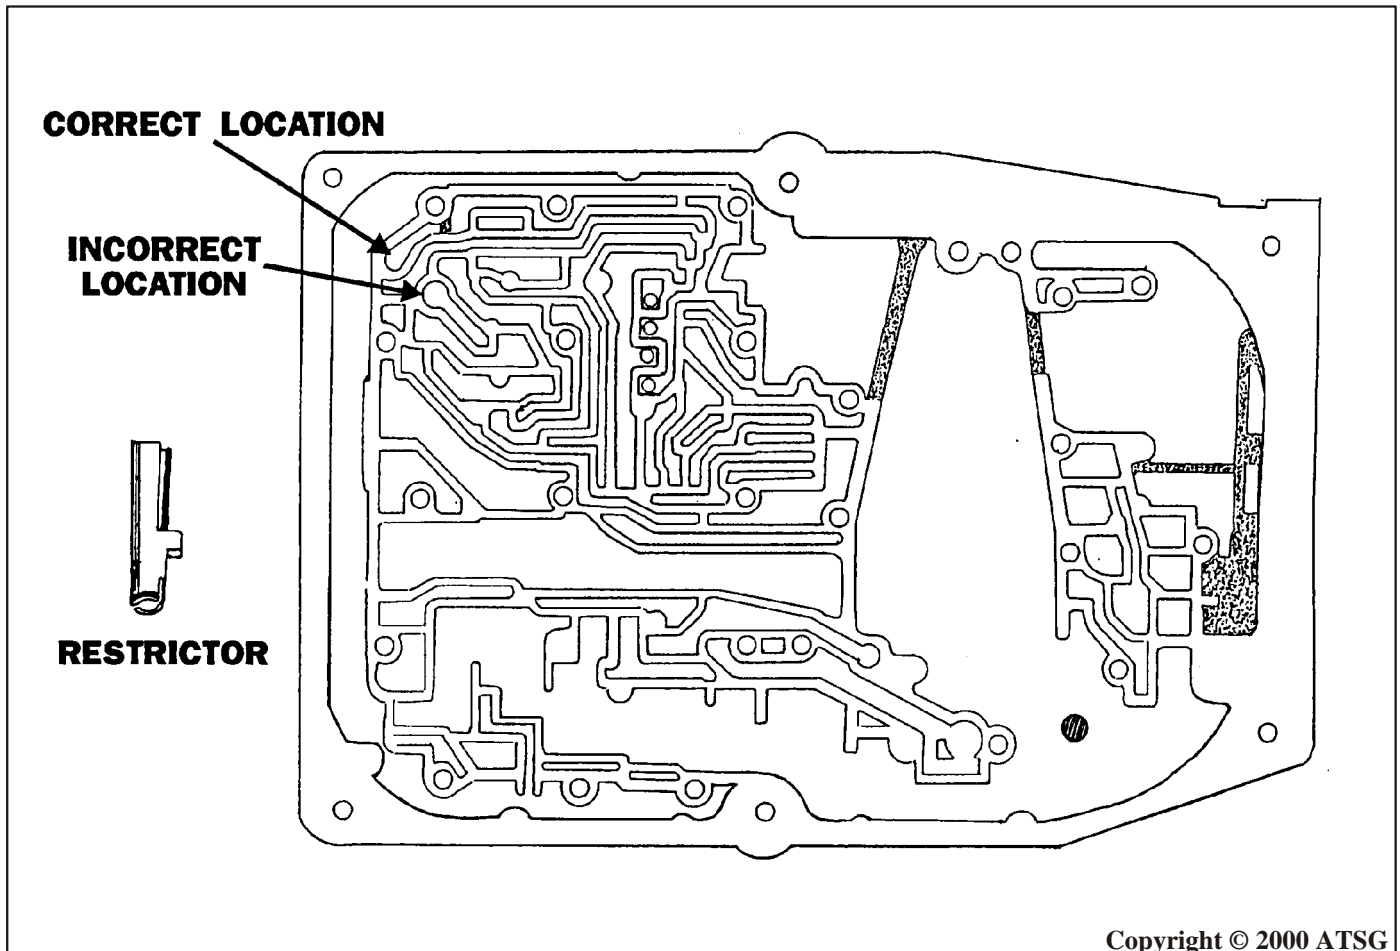
**COMPLAINT:** Some 190 series transmissions may experience a harsh reverse engagement into reverse after an overhaul. All of the forward ranges are ok and modulating pressure is within specifications.

**CAUSE:** The reverse feed passage is unrestricted, allowing too much oil volume to the reverse clutches.

**CORRECTION:** Install the Mercedes tapered oil restrictor (Part # 123 277 0319) into the transmission case as shown in figure 1. Note that the restrictor goes in tapered end first and fits snug in the case.
