- Intermittently No Connection in Reverse (power Interruption)
- Transmission Slips When in Reverse

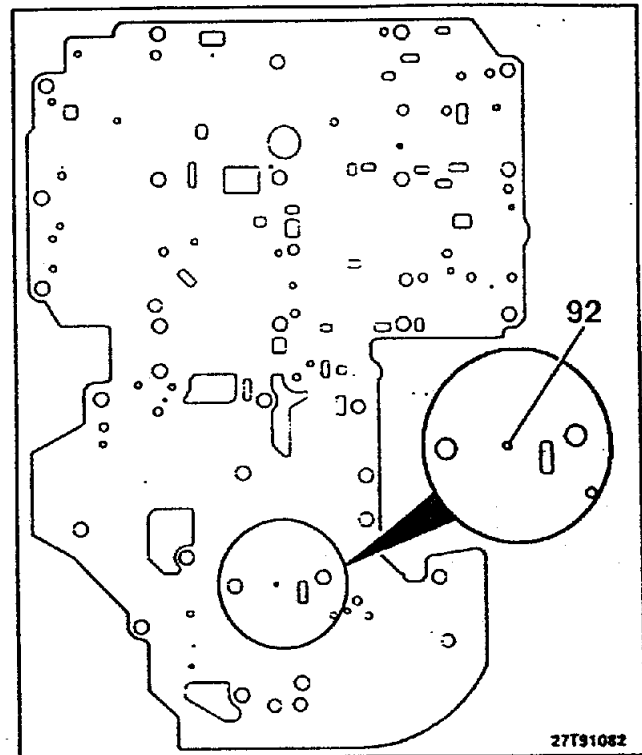
**Figure 1**

Extremely high Reverse engagement pressures leaking between Bore 92 of large intermediate plate and Drain valve KS (103) in transmission case due to:

1. Bore 92 is too large (4 mm diameter).
2. Graphite gasket material of original large intermediate plate gasket not sealing properly.
3. Steel cover plate (2, Figure 2) on upper side of large intermediate plate becoming loose or of uneven tightness.

722.5 large intermediate plate.

Correct diameter of Bore 92 = 2.0 mm

1. Replace large intermediate plate, part no. 129 277 15 14. Ensure Bore 92 of replacement plate is 2 mm diameter (Figure 1).
Tightening torque: 8 Nm
2. Replace large intermediate plate gasket, part no. 129 277 09 80.
3. Replace or retorque steel cover plate (2, Figure 2), part no. 129 277 19 94. Tightening torque: 4 Nm.

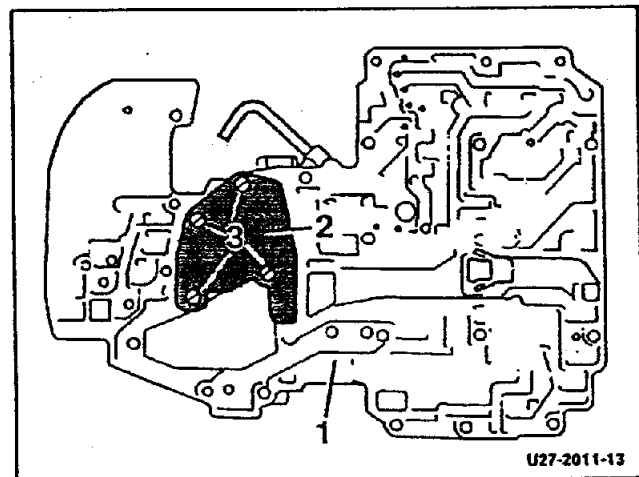
**Figure 2**

- ▶ Steel cover plate (2) is not flat, but is manufactured with a curve or bow to its facing surface.
- ▶ It is critical that the center of the steel cover plate curved arc contacts the gasket first, and is flattened as the fastening screws are tightened.

Upper side of 722.5 large intermediate plate (1) showing steel cover plate (2, shaded).

Fastening screw (3) tightening torque: 4 Nm
