Mercedes 722.1-722.2

Mercedes automatic transmission technical tips

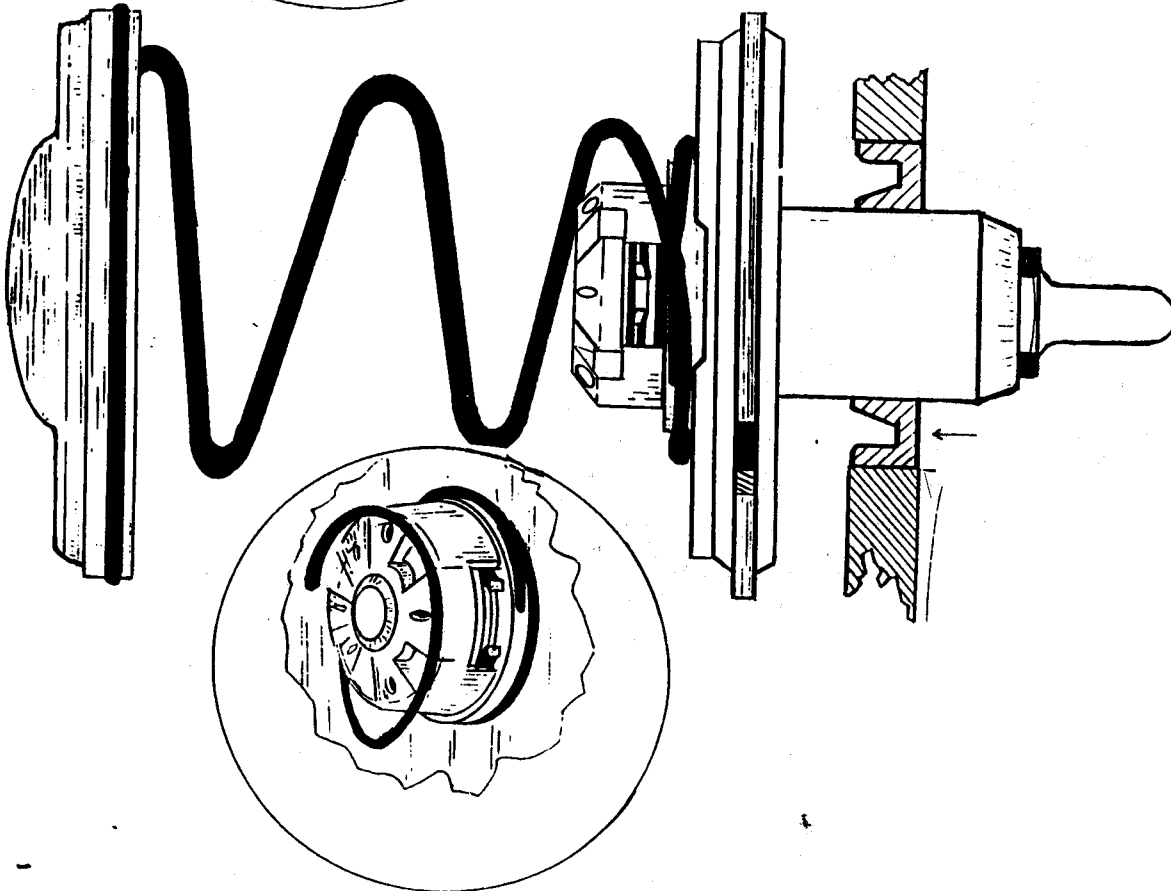
NOTE:

COMPLAINT: No Forward / slipping in Drive
Coast downshift clunk or bump.
Delayed engagement in Drive.

CAUSE: Broken plastic cap on servo piston.
Improper installation of spring seat.
Improper installation of servo piston spring.

This illustration shows the correct installation of the servo spring. It must be placed on TOP of the servo piston and against the cover.

CORRECTION: Be sure to have exhaust valve line-up as shown in Figure 1.
Be sure to install spring line-up as shown and spring seat installed as shown in Figure 1
Be sure that plastic cap is seated on servo piston as shown in Figure 1 and the spring line up on piston as shown in Figure 2
spring is seated on TOP of servo piston NOT on bottom.
